# **Biological Monitoring Report**

**Combined Sheet Pile and Soil-Bentonite  
Barrier Wall Construction**

**McCormick & Baxter  
Creosoting Company  
Portland, Oregon**

**October 2003**

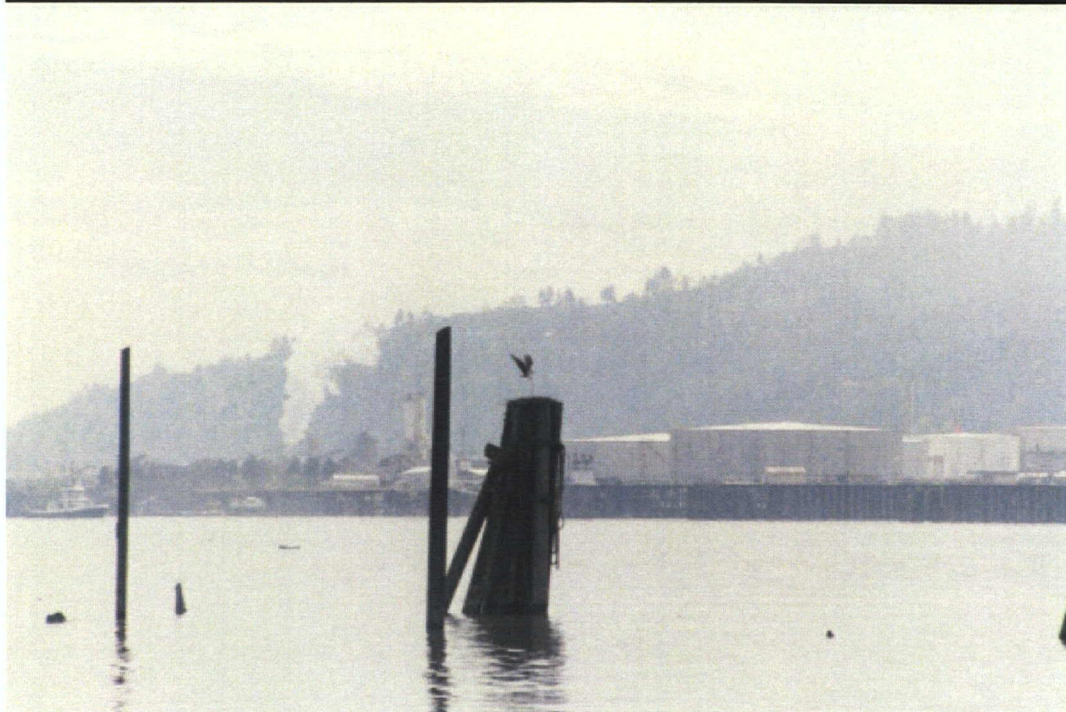
Directly offshore of the northwest beach, an osprey nest was observed on one of the pilings. The nest was still being built at the time of the survey. In addition, one bald eagle was observed flying over the site. No additional threatened, rare or endangered species were observed.

Photo 5 Osprey building nest.  
*Direction: South*

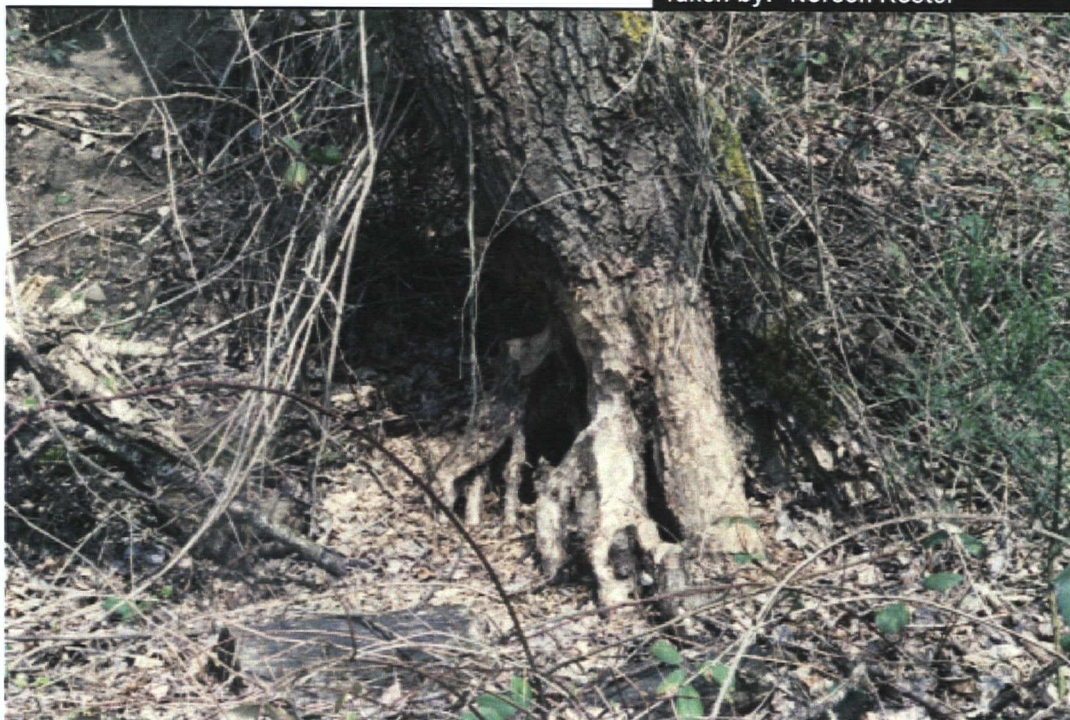
Photo 15 Nutria or beaver activity.  
*Direction: East*

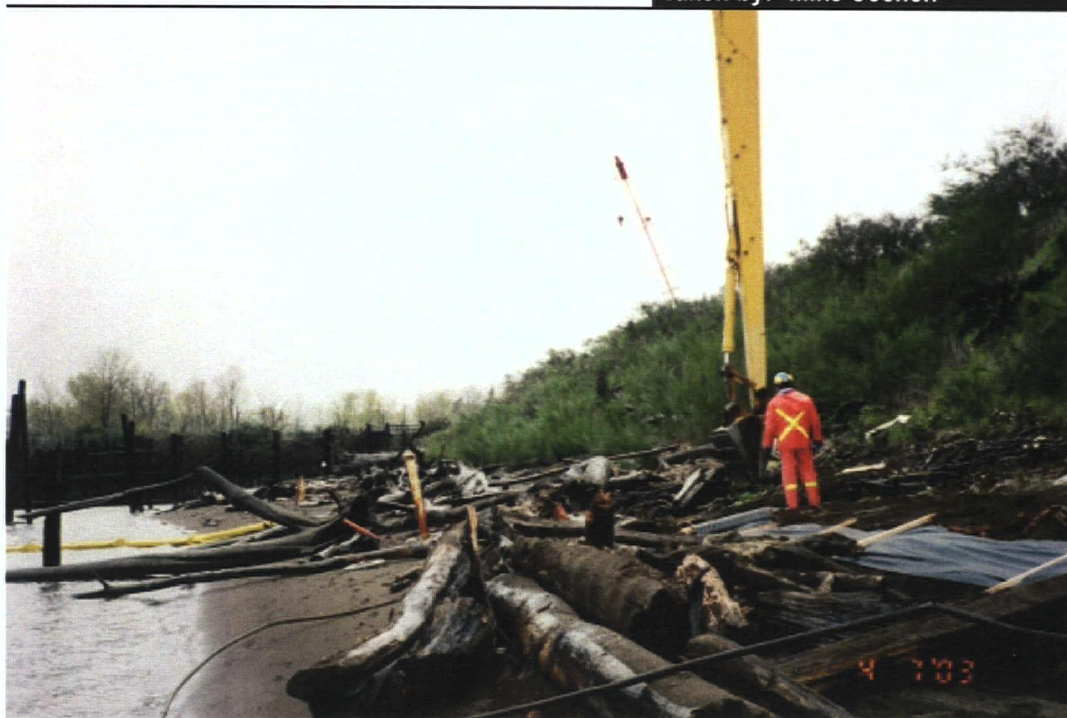
Most of the pre-existing woody debris that was deposited along the shoreline of the project site was left on the beach. The debris was pushed slightly waterward to make room for the installation of the silt fence. Those pieces that were observed to be contaminated (approximately 20 cubic yards) were removed from the beach to an upland location on site.

Photo 16 Crew is moving logs waterward on southeast beach to prepare for installation of silt fence.  
*Direction: Northwest*

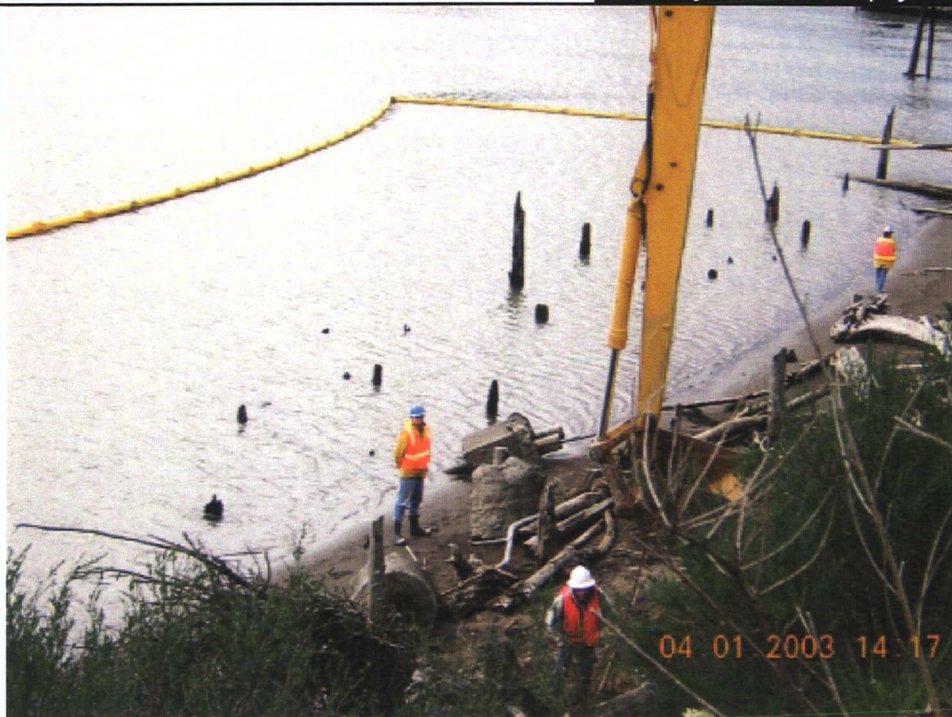
Photo 17 View of boom and log displacement at southeast beach.  
*Direction: West*

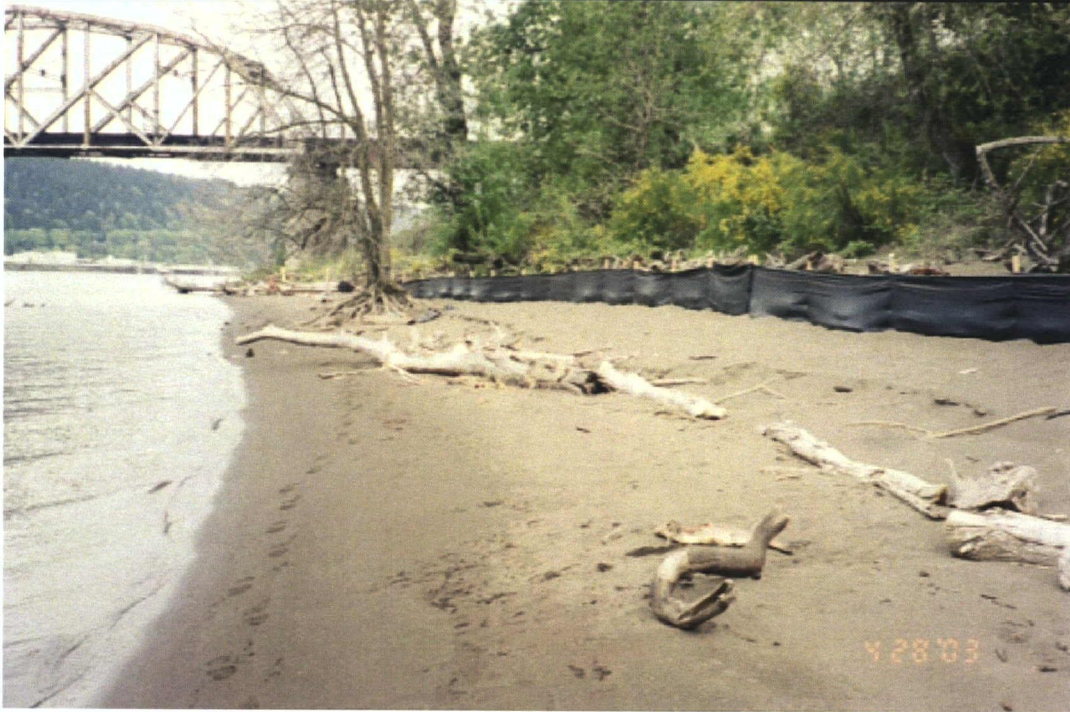
Photo 19 Silt fence along northwest beach.  
*Direction: Northwest*

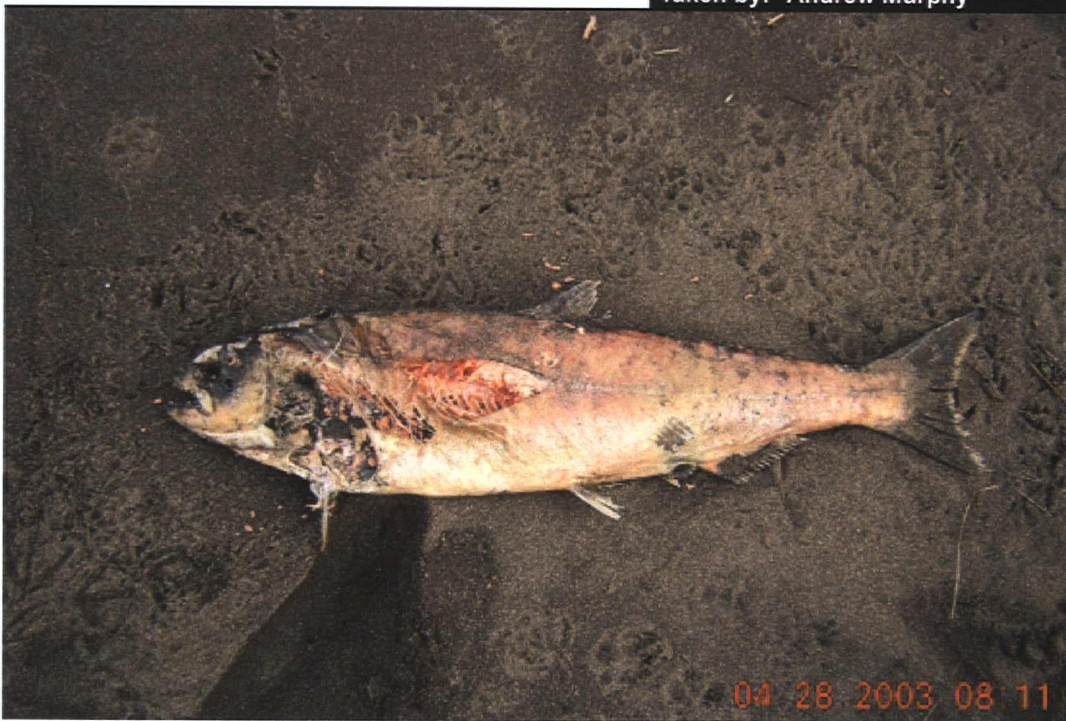
One dead Chinook king salmon (*Oncorhynchus tshawytscha*) was found on the morning of April 28, 2003, on the northwest beach approximately 10 feet south-east of Station 12+00. The fish was approximately 33 inches long, and partially decomposed around the eye and jaw area. The specific cause of death is unknown. However, based on the state of decomposition, the fish appeared to have been dead for a day or more.

Photo 20 Dead *Oncorhynchus tshawytscha* found on northwest beach.  
*Direction: Down*

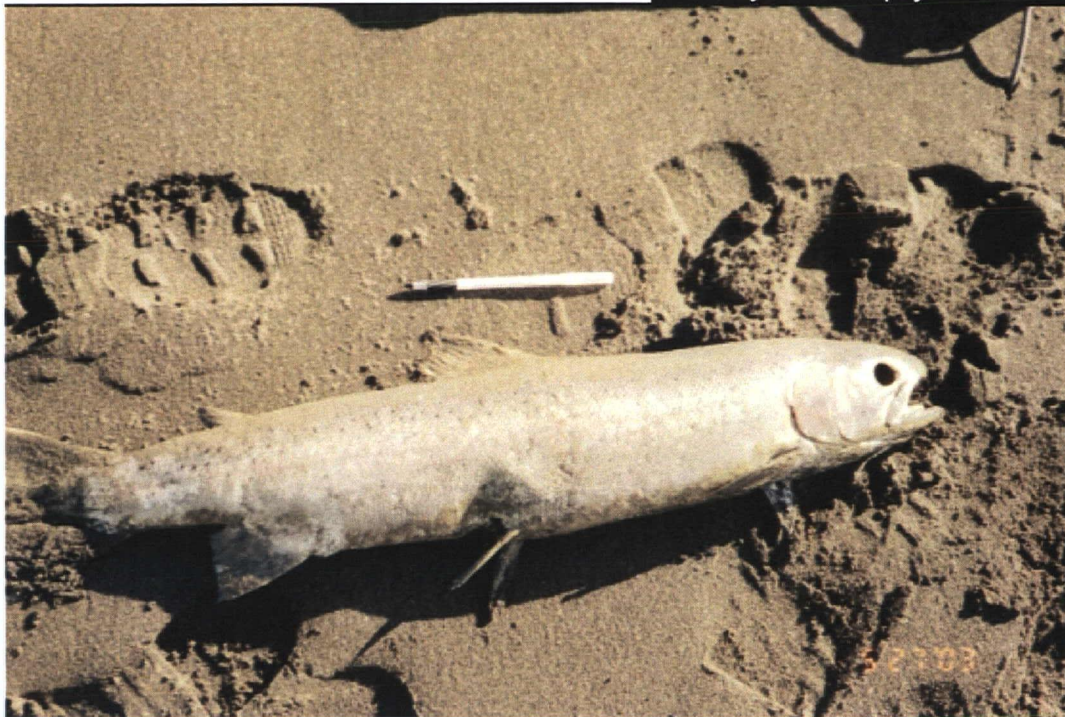
One dead steelhead (*Oncorhynchus mykiss*) was found on the morning of May 27, 2003, at the northwest beach near STA 10+35. The fish was approximately 28 inches long and in fair condition. The specific cause of death is unknown.

Photo 21 Dead *Oncorhynchus mykiss* found on northwest beach.  
Direction: Down

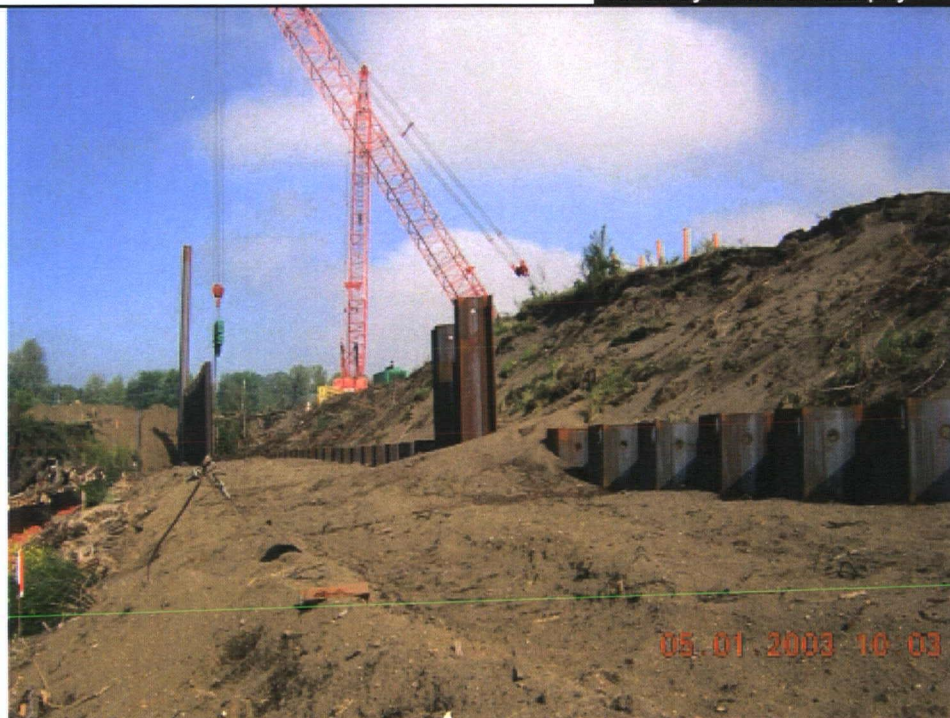
Photo 22 View of bank erosion at southeast bank.  
Direction: Northwest

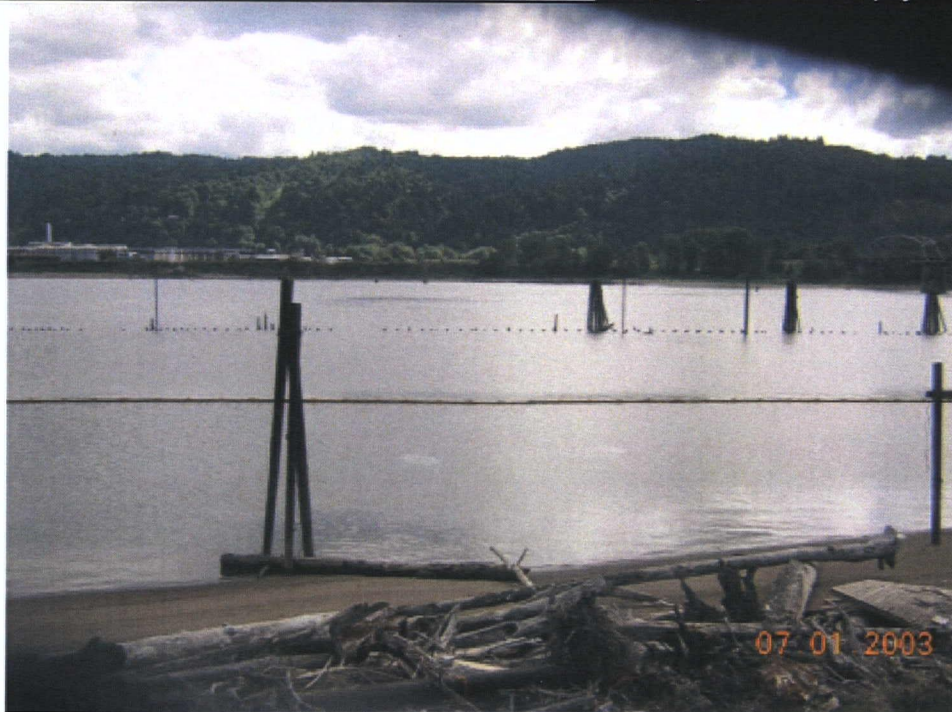
A skirt boom was deployed on April 1, 2003, before construction activities. The boom was moved in accordance with locational changes of construction activities. During the driving of sheet piles, the body of water within and outside the defensive boom was monitored for the presence of any sheen that may be produced as a consequence of sheet pile installation. On several occasions, sheen was observed within the defensive boom during sheet pile operations, and during periods of construction inactivity. Sheen was typically observed during low tides and temperatures greater than 75° Fahrenheit. Sheen was not observed to be a consequence of sheet pile installation activities or other construction activities. Absorbent pads were deployed within the boom area and removed routinely throughout construction. Photographs were taken and are presented in Appendix C.

Photo 23 Observed sheen in water.  
*Direction: West*

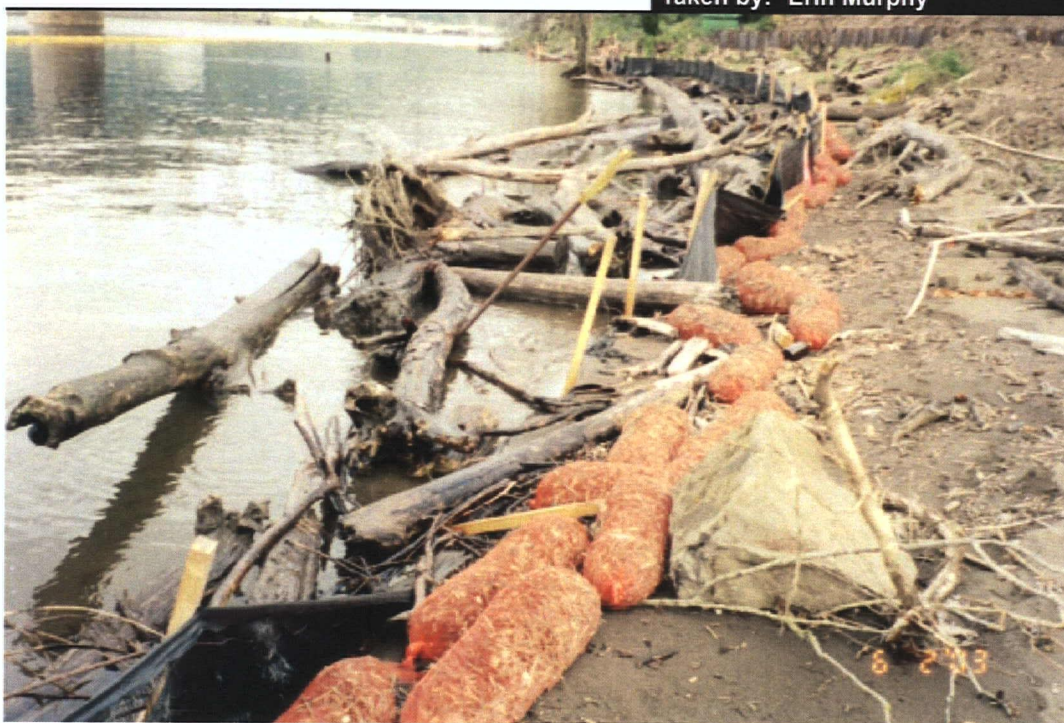
closer inland to avoid further impacts. Although one segment of the silt fence was moved slightly inland, high water levels on June 2, 2003, inundated the silt fence and biobags. E & E recommended complete removal of the silt fence and biobags in areas where construction was no longer active.

Photo 24 Silt fence and bio-bags on northwest beach after a high water event.  
*Direction: Northwest*

During high water events, E & E recommended to the contractor to move all materials, including silt fencing, biobags, and equipment, from the water's edge.

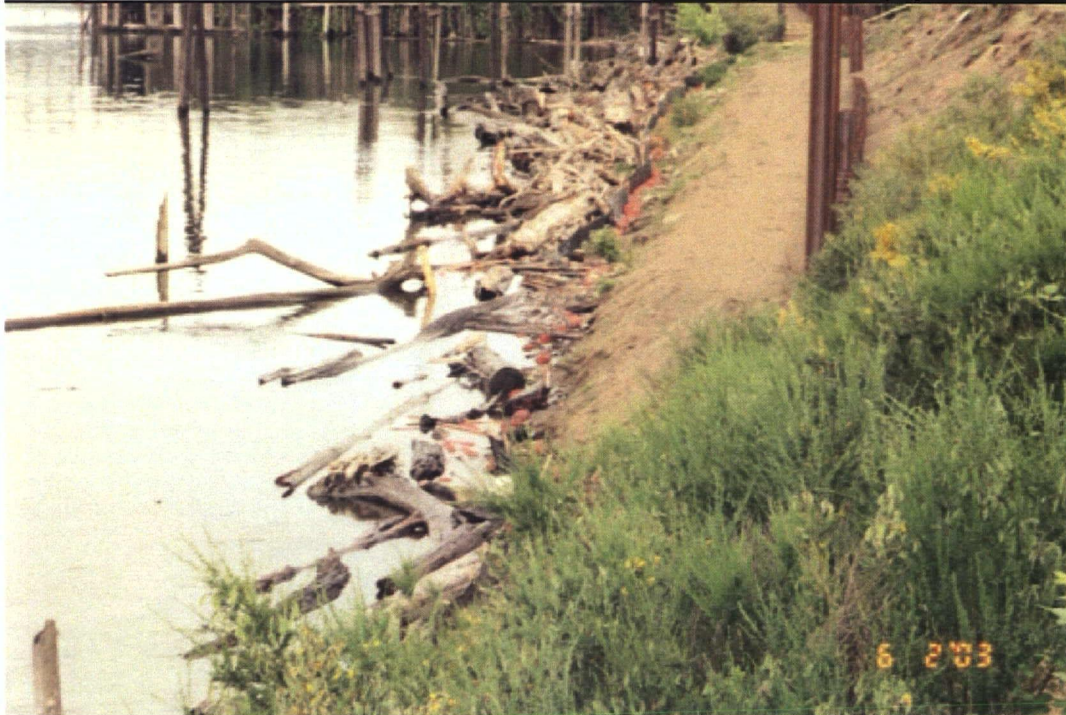
Photo 25 Silt fence and bio-bags on southeast beach after a high water event.  
*Direction: Northwest*
